APPENDIX A

ARCHITECTURAL DESCRIPTIONS AND RECOMMENDED TREATMENTS FOR THE HONEYWELL COMPLEX ON BOCA CHITA KEY

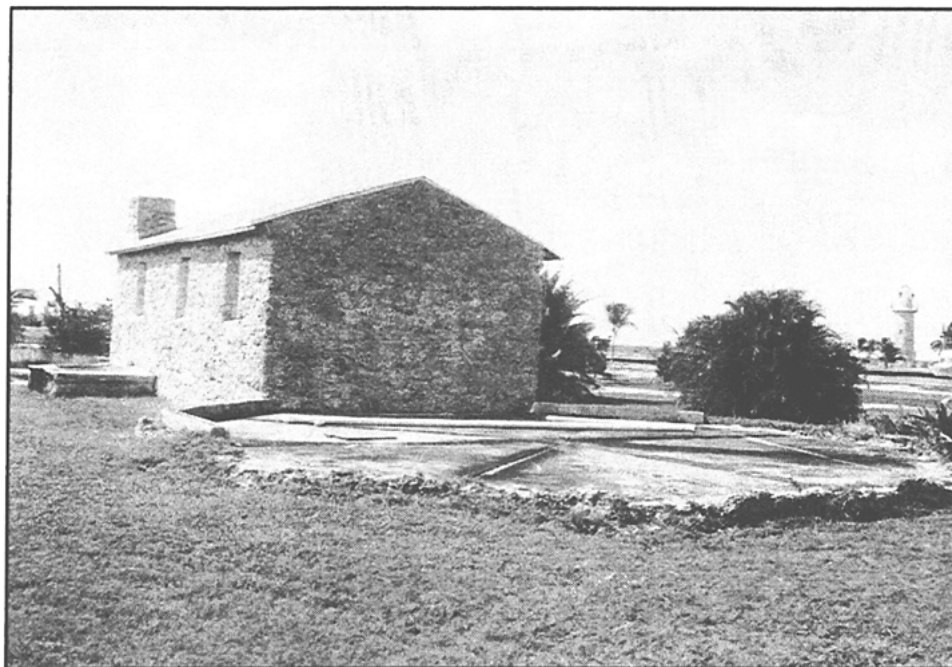
Figure A- 1. Engine House, 1997

Boca Chita Engine House and Cistern (IDLCS 90194; HS-5): Also known as the generator building, this concrete block structure with concrete slab foundation measures 15½ feet by 32½ feet. The rear third of the structure is built of a different type of concrete block than the front, although no corresponding variation can be discerned on the exterior. The exterior walls are of uncoursed oolitic limestone. The front-gabled roof has been re-covered with asphalt/fiberglass shingles, replacing the old roof damaged by Hurricane Andrew. The narrow building front has a door and window. The door appears to be original. The rear wall has no openings. Originally, the rear was gabled, but it is now hipped as a result of repairs undertaken after Hurricane Andrew. An octagonal concrete cistern, 15 feet on each side, is attached to the rear (east) of the building. A shed porch on the south side of the building was demolished by the hurricane and will not be rebuilt.

Problems and Recommended Treatments- At the time of the site visit the windows were covered with plywood. The original windows should be repaired or replaced to match the originals. Staining beneath the windows should be poulticed.

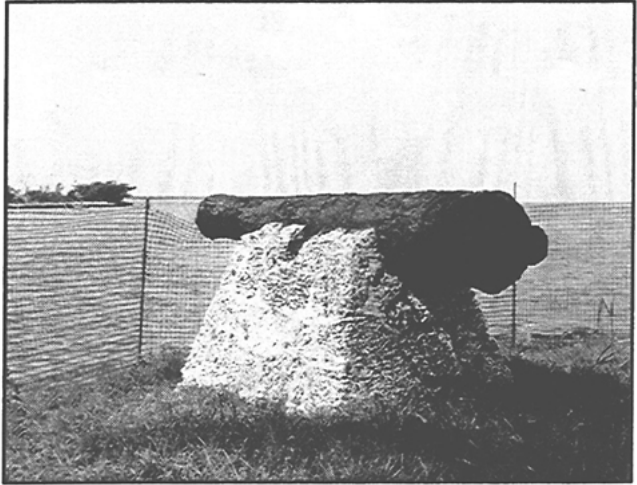
Figure A- 2. Cannon, 1995

Boca Chita Cannon: The cannon is cradled in a stone base with small depressions on either side to hold the gun's trunnions. The stone of the base is in good condition, but the cannon is badly corroded, with the outer layers exfoliating. The muzzle of the gun is open, allowing water to enter and, incidentally, providing a nest for a crab. This cannon apparently was cast in two

parts, with the inner section and outer of two different alloys. Where the inner material is exposed near the muzzle it does not appear corroded.

The surface of the cannon needs to be protected from both rain and saltwater. The surface will need to be prepared by the removal of rust, which in this case will be difficult because of the extent of the corrosion. Only manual methods should be used to remove the corrosion; a wire brush should probably be used, but chemical application might also be a possibility. The metal should then be stabilized by painting with primer and a black finish coat appropriate to the salt environment. The joints where metal rests against stone should

be carefully examined for openings where water could pool against the gun or flow under it and the openings sealed. The mouth of the gun should be plugged to prevent water infiltration.
